# IRATA Safety Notice

## IRATA Work and Safety Report 08/01

### Summary of incidents reported on Form 021 2006/2007

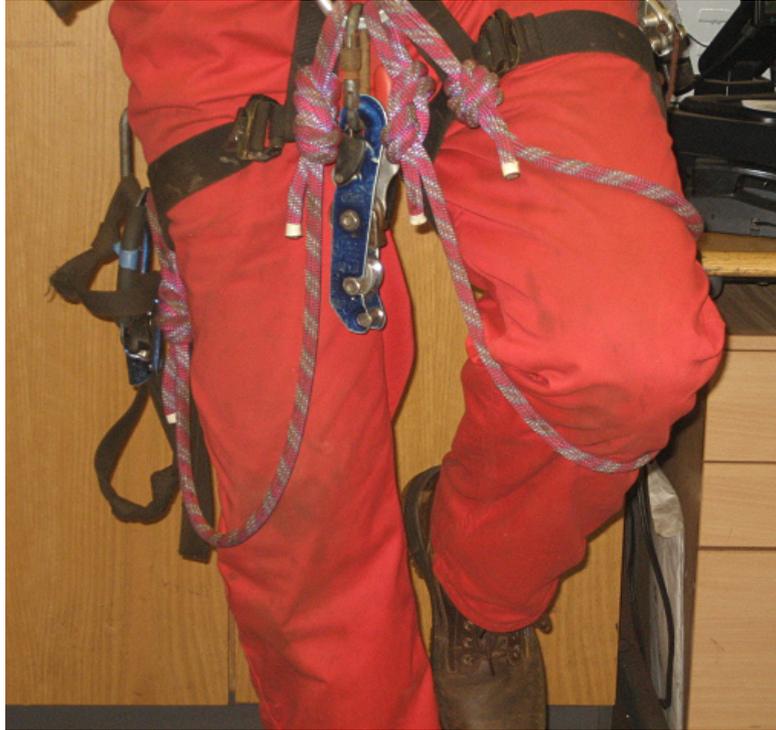
**Incident where a cow's tail caught round a technician's knee as he stood up.**

The photo illustrates a not unusual occurrence, which is usually without serious consequences. However this turned into a lost time incident, as it was necessary for the technician to be evacuated with a back strain.

Trainers are advised to emphasise suitable stowage of cow's tails and foot loops when not in use to prevent this happening. There are a variety of ways to do this by tucking them into leg loops or shortening them. Level 3s and buddy checking of each other should encourage this safe practice.

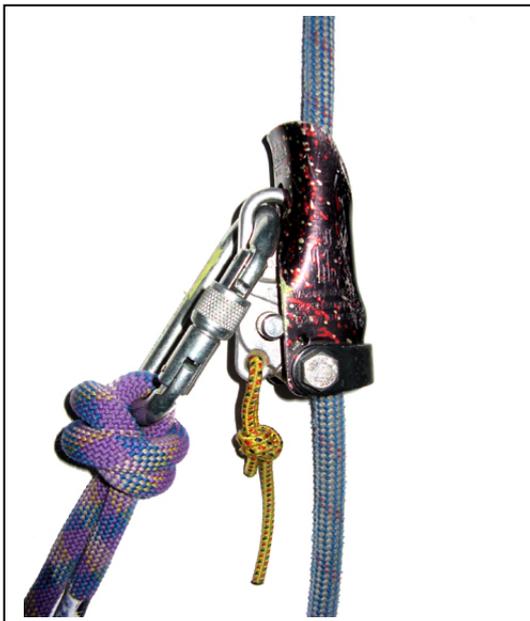
**Photo 2**  
**Shunt retained by karabiner to prevent dropping.**

**Warning:** This is dangerous if accidentally loaded in this way.

**Petzl Shunt:** Before removing the shunt from the rope, remove the karabiner and carefully push the cam through the body to other side of the rope and replace the karabiner through the cam. [See photo 2]

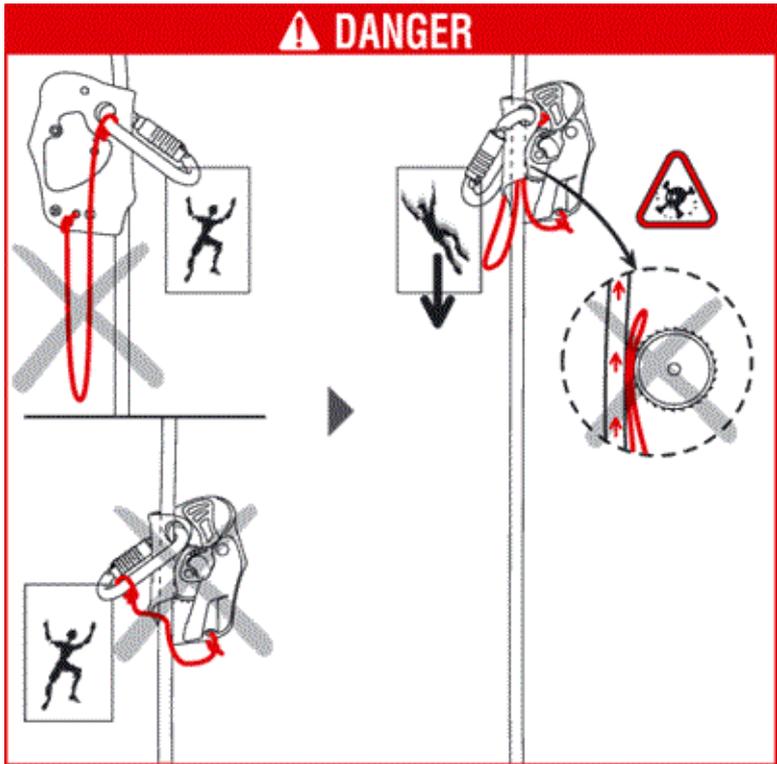
Fig. 2

- If the keeper cord is longer than 11 cm when tied to the device.
- If the keeper cord is on the wheel side of the ASAP.

There's a risk that the keeper cord may get jammed in the toothed wheel, causing the ASAP to malfunction.

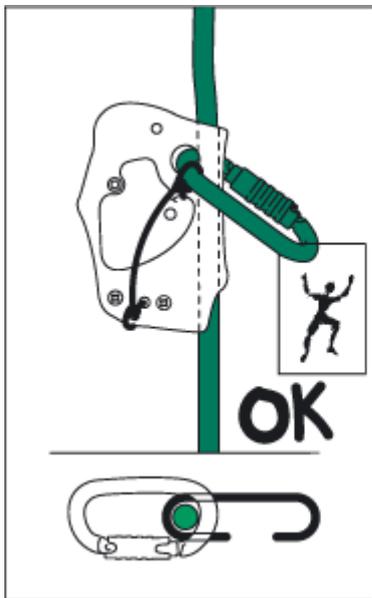
Fig. 3

**WARNING:** when using the ASAP, the OK TRIACT karabiner must be clipped through the 2 attachment holes and the rope must run inside the karabiner. IF NOT, DANGER OF DEATH (fig. 3).

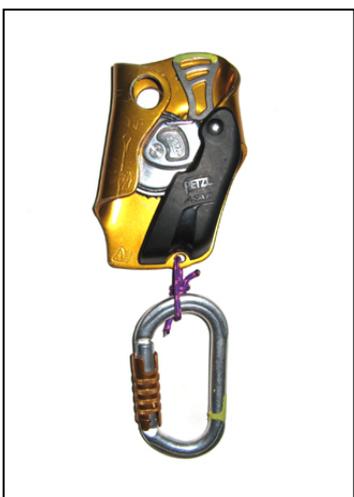
Photo 3

**Photo 3:** Shows an alternative where the lanyard karabiner is placed in a small loop of cord in the lower hole to prevent dropping the ASAP as it is removed. Warning: this is obviously dangerous if the ASAP is loaded by this karabiner from this loop.

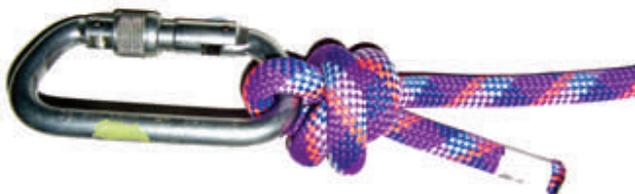
**Figure 7**  
This dangerous knot is a tightened version of Figs 4 - 6 and looks very like Fig 3 at first sight. **This is not a slip knot and the important difference is that the tail will pull through if the cow's tail is loaded.**

**D  
A  
N  
G  
E  
R  
O  
U  
S**

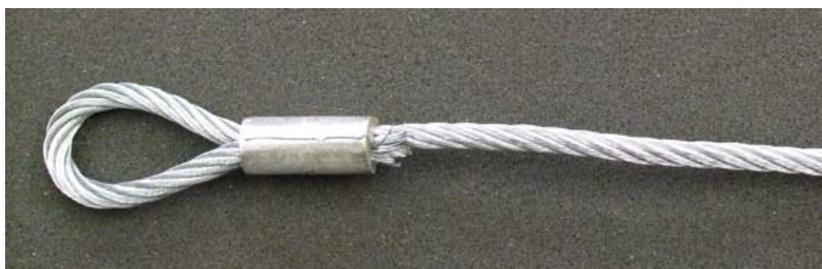
A member working on an oil platform issued a non conformity / improvement opportunity report, after it was noticed that sparks had come from a galvanised wire anchor sling. Since the possibility of causing a spark is obviously to be avoided in any potentially explosive atmosphere the work was stopped. In a safe area, the sparking was replicated by rubbing the wires on a piece of rusty steel.

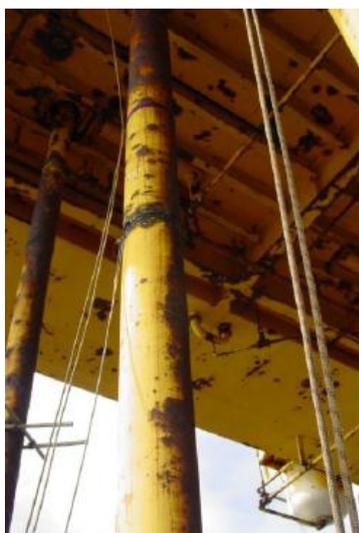
Figure 1 - Area in which rope access hot work was taking place

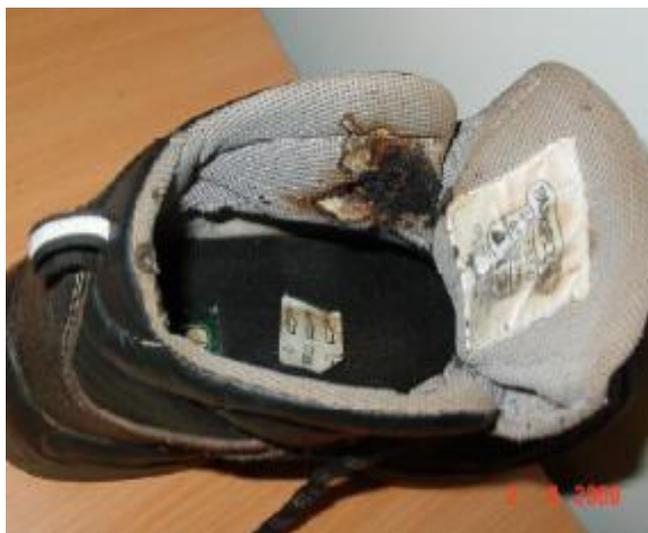
Figure 2 – Injured person's safety shoe showing burn damage

- ◆ Protective jackets used for hot work should close using "velcro" closing straps rather than buttons;
- ◆ Consideration should be given to different kinds of protective clothing, including flexible fireproof hoods designed to cover shoulder, chest and neck area;
- ◆ It should be emphasised at toolbox talks and in preparation for hot work that molten particles can enter PPE through the smallest openings.

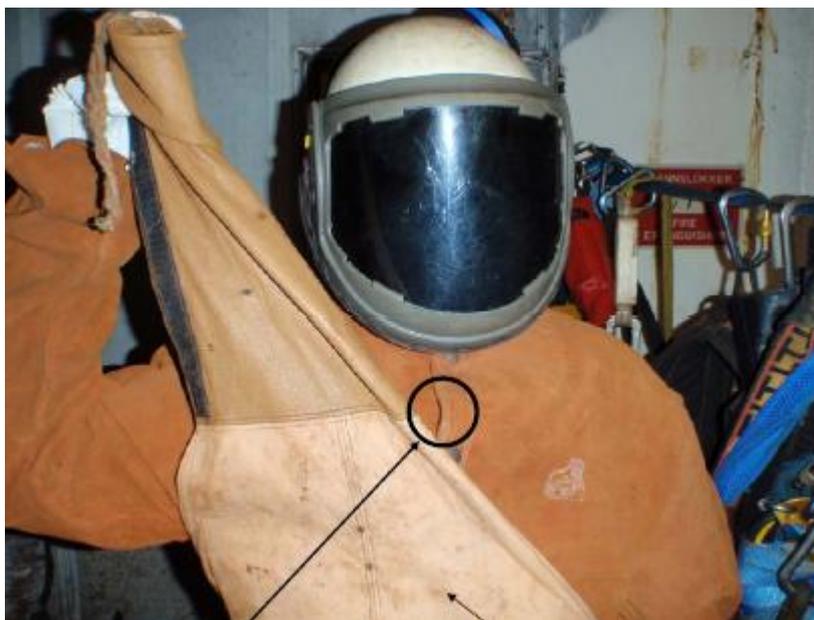
Figure 1 - Protective clothing for rope access technicians showing small opening through which hot particle passed

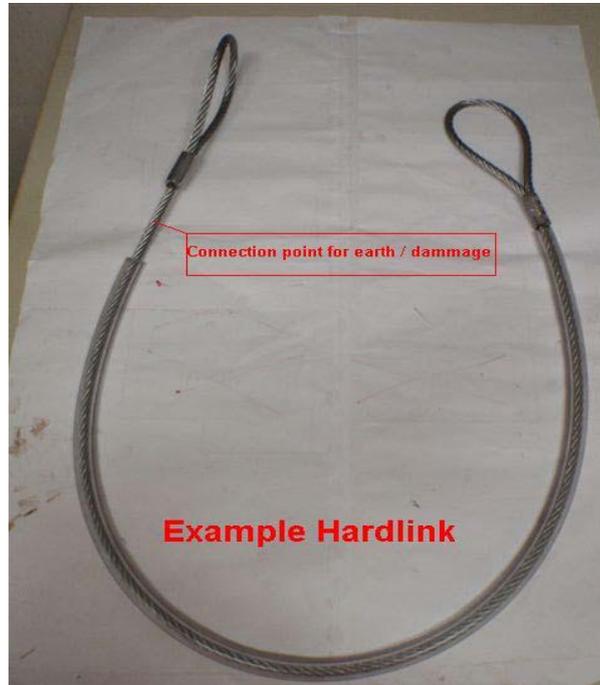
Figure 1 - Typical metal 'hard-link' for rope access technicians

- ◆ Replace metal hard-link with a non-conductive nylon climber's sling;
- ◆ Ensure water is drained out of air supply before use with gouging torch.

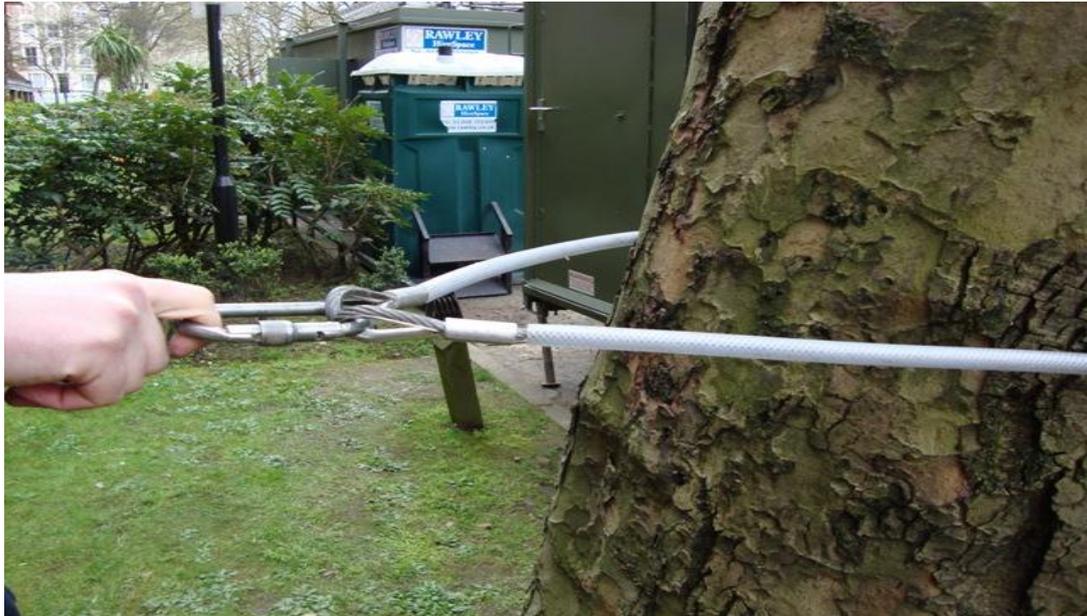
Photo 1: Strop set up as a Primary Anchor. There were four of these together to anchor four ropes.

**4.2** Where the load is offset from the perpendicular, suitable measures should be put in place to prevent ropes or anchor slings sliding in the direction of loading, particularly on smooth linear structures such as this tree, steel or concrete beams.

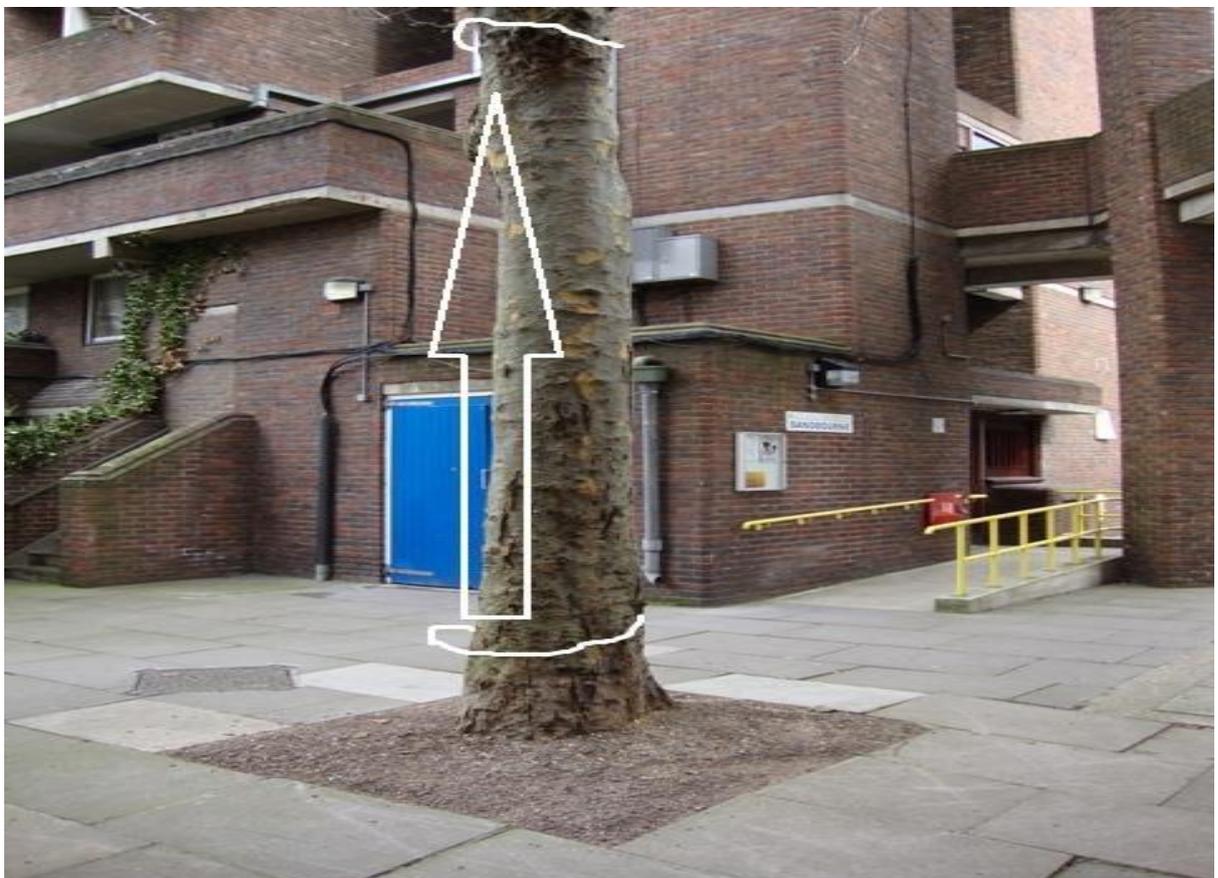
Photo 2: Indicating (approximately) where the ropes were originally rigged (at low level) and where they eventually came to a stop.

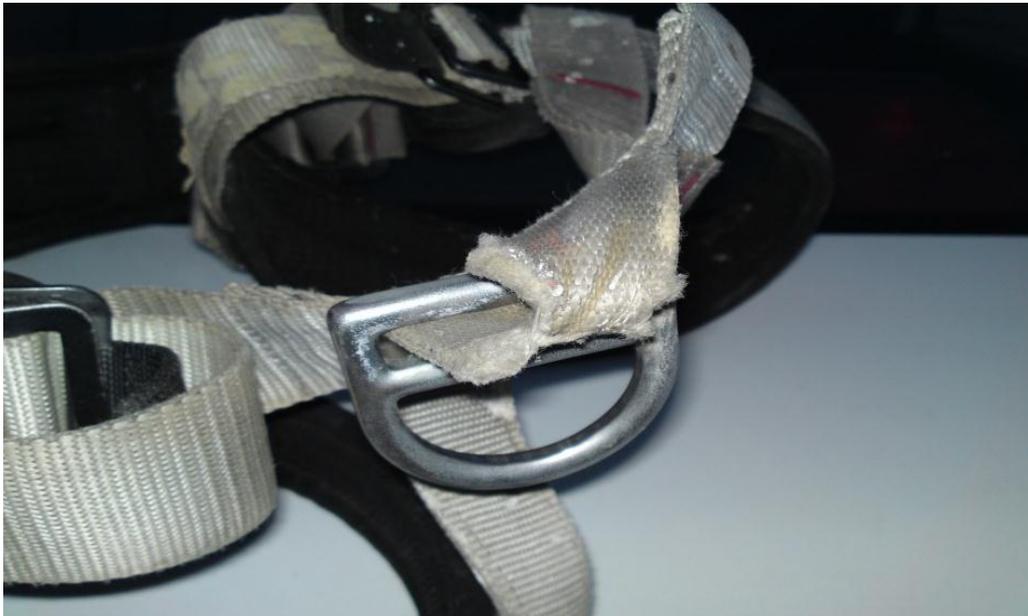
- 4 Excessive wear on the harness webbing attaching the D-ring.  
**Action:** Pay attention to areas of high wear. Be aware that damage which builds up slowly may not be as obvious.

**Excessive wear on webbing loop of a sit harness**
