# IRATA Safety Notice

## IRATA Work and Safety Report 08/01

### Summary of incidents reported on Form 021 2006/2007

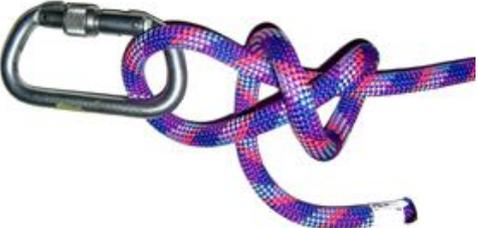
**CORRECT version of a Scaffold / Barrel knot: See figure 1 – 3 below; Stages in tying.**

<p><b>Figure 1 -</b> This is tied by passing approximately 50cm of the tail end of the rope over the karabiner and tying half a double fisherman's knot around the section going back to the harness.</p>

<p><b>Figure 3 -</b> <b>This is a slip knot which tightens when loaded.</b> In a pre-use check, the knot should be adjusted for length and loaded; the tail should also be tightened. If the knot is not adequately tightened the wraps may work loose and come undone. It is good practice to unfasten and re-tie cow's tail knots periodically to avoid them becoming over tightened.</p>

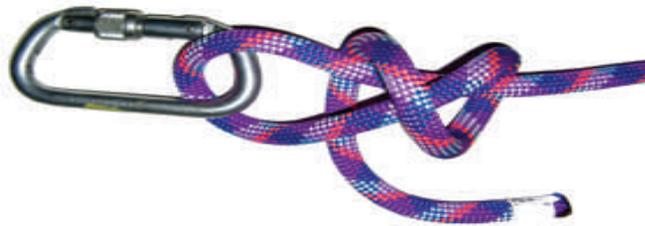
**Figure 1**

### CORRECT version of a Scaffold / Barrel knot: Figs 1 - 3 Stages in tying

This is tied by passing approximately 50cm of the tail end of the rope over the karabiner and tying half a double fisherman's knot around the section going back to the harness.

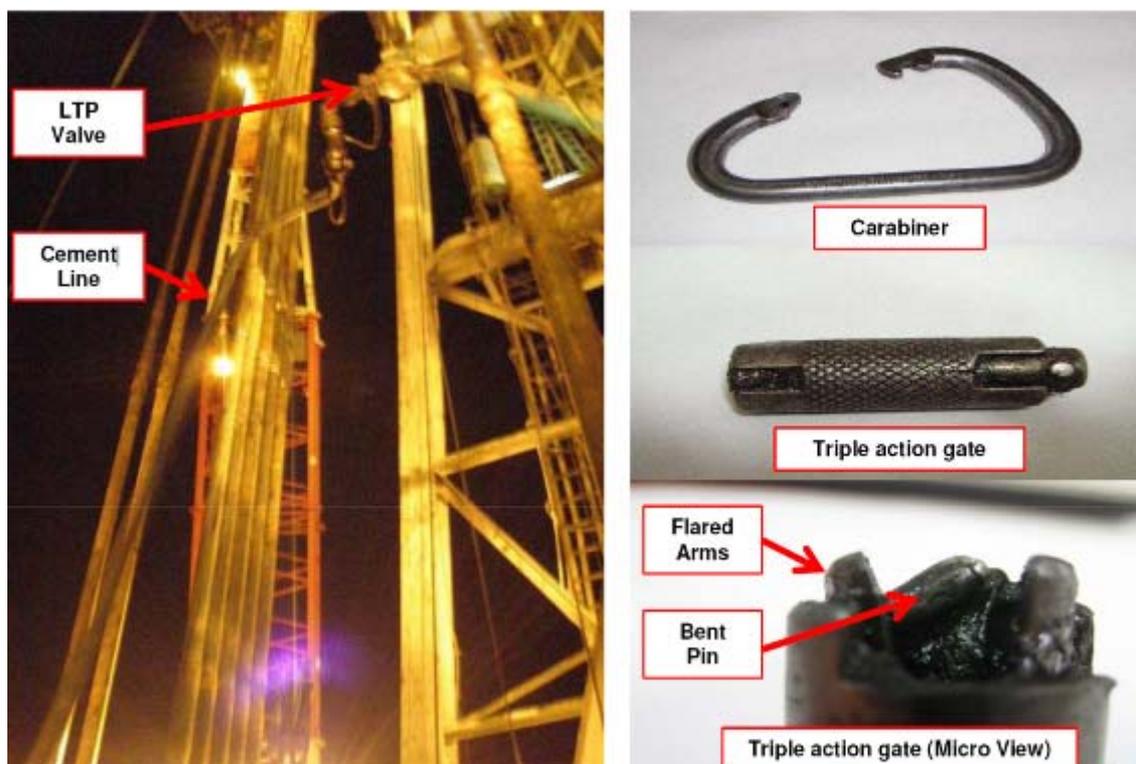
## Manriding Incident – Carabiner Failure

Operation of the valve involved some physical movement of the man in the riding harness. The man-rider then pushed away from the valve, grasped a cement hose with his right arm and signalled to the tigger operator to commence lowering. As lowering began, the carabiner locking gate broke free from the carabiner body. The man-rider became disengaged from the tigger wire rope and fell to the rig floor. Because he was holding the cement hose, this action slowed his descent. He landed feet first and rolled to absorb the fall.

Examination of the carabiner was carried out by a Materials and Corrosion Engineer. A considerable amount of dirt was found lodged around the latch pin and between the latch yokes. This contamination may have prevented full gate closure of the carabiner by stopping the gate sleeve from rotating to lock the latch. This would have left the tensioner spring as the only mechanism holding the gate closed.
